INDOOR AIR QUALITY ASSESSMENT

**Department of Veterans' Services
239 Causeway Street, 1st Floor
Suite 100
Boston, Massachusetts**

Prepared by:
Massachusetts Department of Public Health
Bureau of Environmental Health Assessment
March 2003

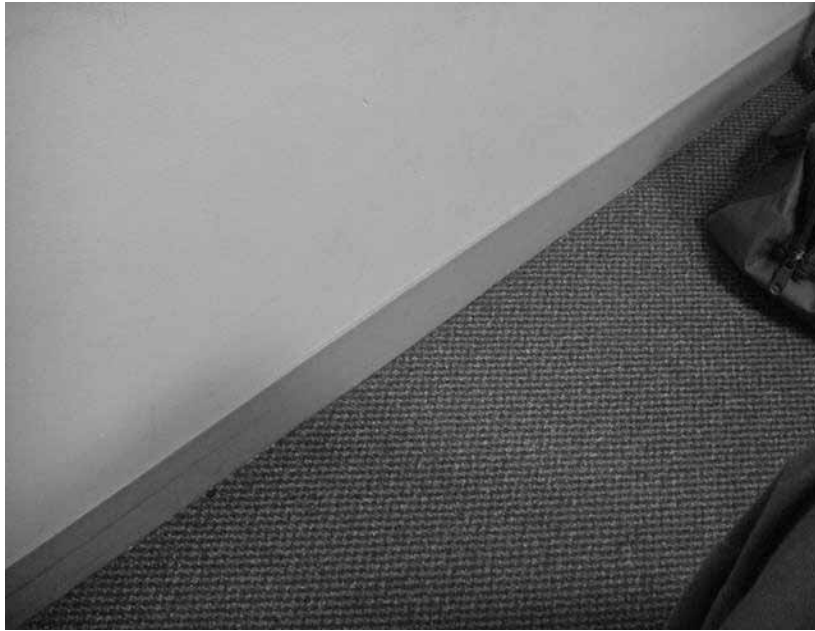
Picture 1

Suite 100 was renovated in 1998, prior to occupancy by the DVS. GW was installed in many areas of the basement. Each section is held in place with drywall screws. GW was painted and covered with plastic coving at its base (see Picture 1). A flood remediation contractor removed the plastic coving from many sections of wall throughout Suite 100 (see Picture 2). The plastic coving is a water impermeable material.

Example of Plastic Coving At Base of GW Wall (MDPH Office)

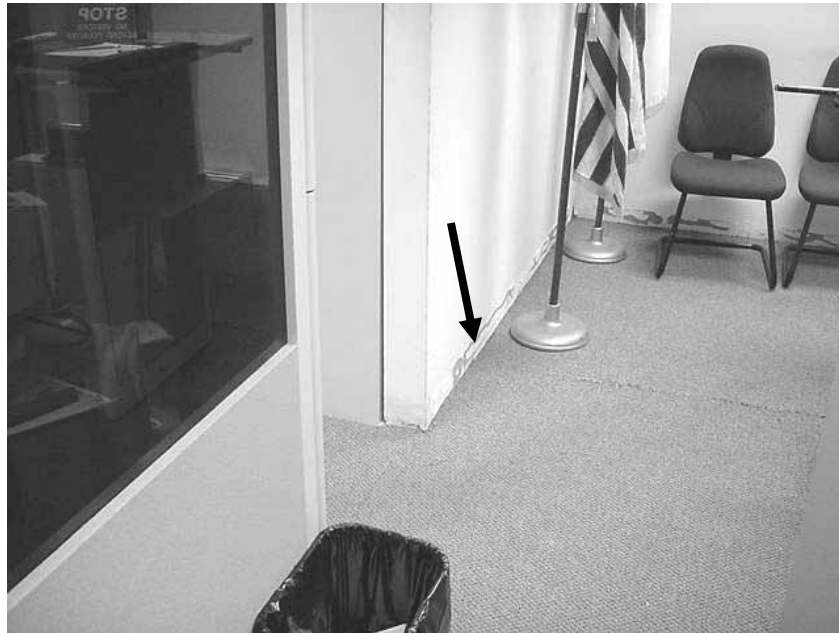
Picture 2

GW With Plastic Coving Removed

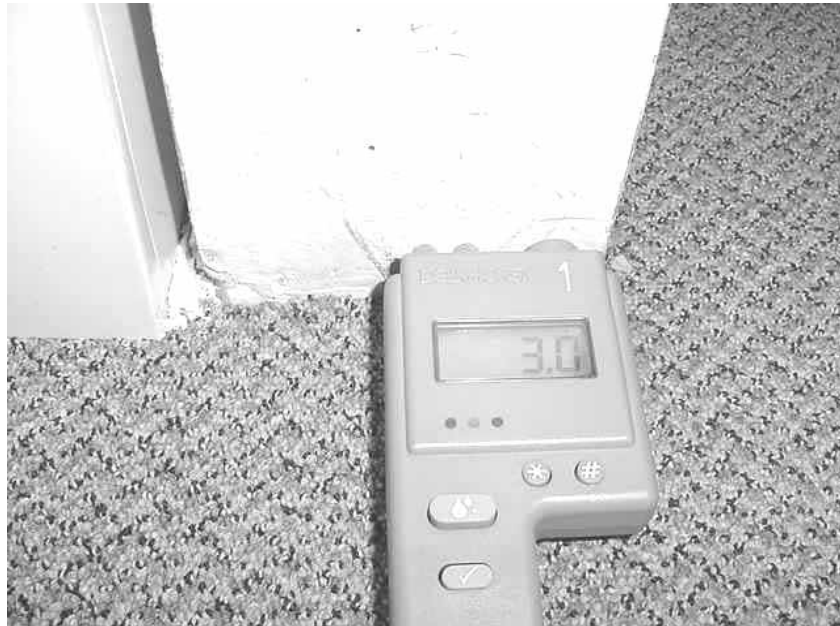
Picture 3

In order to assess whether carpeting and GW (particularly sections that were under coving) had dried, moisture content of these materials was measured and is listed in the Tables. Moisture content of GW was measured 12 inches above the floor using a Delmhorst, BD-2000 Model, Moisture Detector (see Picture 3). Moisture content of carpeting was measured in random areas or where floor buckling was noted. No carpeting had detectable moisture readings. A number of areas of GW continued to have elevated moisture concentration a week after the flood (see Tables), despite the best efforts to dry this material. Water saturated GW can support mold growth if it remains moistened. The American Conference of Governmental Industrial Hygienists (ACGIH) recommends that porous materials (e.g., GW) be dried with fans and heating within 24 hours of becoming wet (ACGIH, 1989). If porous materials are not dried within this time frame, mold growth may occur. Water-damaged GW cannot be adequately cleaned to remove mold growth. The application of a mildewcide (e.g. bleach solution) to moldy GW is not recommended. Bleach consists of sodium hypochlorite in a 5 percent concentration mixed with 95 percent water. The additional water added to the subsurface mold fuels a spurt in growth, which increases mold colonization of the GW. As a result,

GW With a Positive Moisture Measurement

1. GW should be removed in the areas indicated roughly one foot above the floor in the offices with positive moisture measurements (taken one week after flooding occurred) (see Tables).

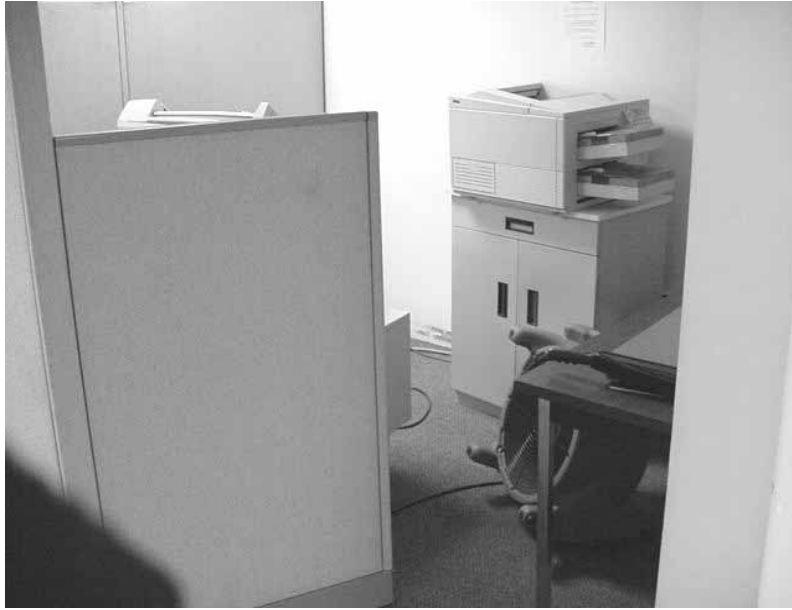
Picture 4

Two other conditions may also have contributed to reports of indoor air related symptoms by DVS staff. In an effort to dry the south offices of Suite 100, a floor fan was placed next to a photocopier (see Picture 4). Photocopiers can produce volatile organic compounds (VOCs) and ozone, particularly if the equipment is older and in frequent use. VOCs and ozone are respiratory irritants (Schmidt Etkin, D., 1992).

Fan Next To Photocopier

4. Move fan away from photocopier.
5. Discontinue use of deodorizers.

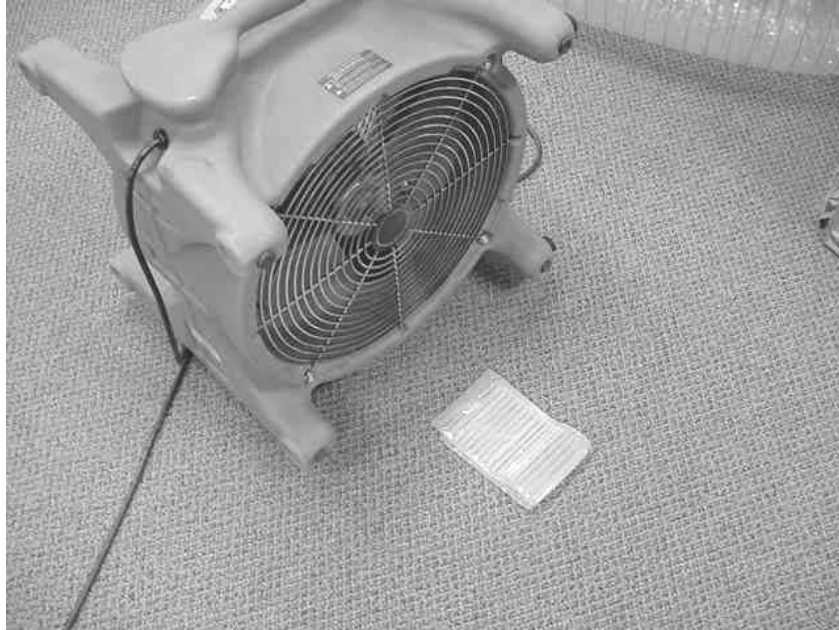
Picture 5

It appears that the consultant hired to re-mediate the area following the flood used a deodorizer. The deodorizer was poured onto a corrugated plastic tray and was then placed near a floor fan to distribute the scent (see Picture 5). Deodorizers frequently contain VOCs that can be irritating to the eyes, nose and throat. The lack of ventilation, combined with drying operations, can cause these deodorizers to remain in the office environment and produce symptoms in exposed individuals. When combined, these factors can serve to exacerbate conditions leading to eye irritations and other indoor air quality/comfort complaints.

Corrugated Plastic Tray Coated with Deodorizer
